Replacing the IC-7800 Reference Oscillator

Reference Failure

Brad Rehm, KV5V
Salado, Texas
January, 2012

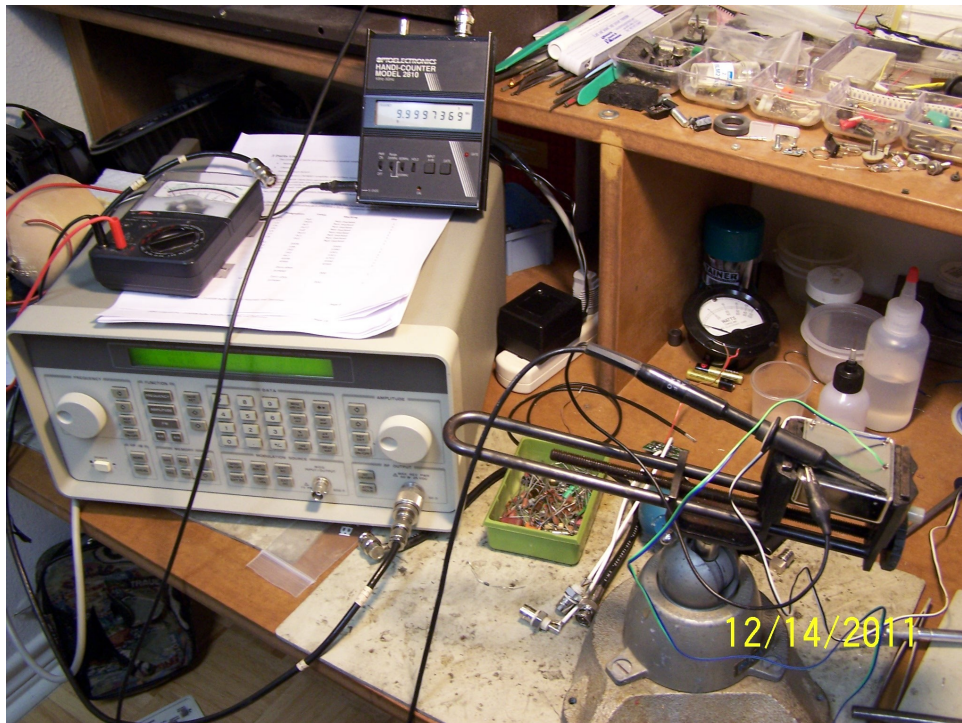
An IC-7800 indicated a 20 to 50 Hz frequency error when transmitting and receiving. A heterodyne was audible while receiving WWV at an indicated 10.000 MHz, and when the internal reference oscillator was directed to the BNC connector on the rear panel so that it could be measured with an external frequency counter, the error was measurable. At a cold start, the reference frequency was low, and it required more than an hour to stabilize at roughly 20 Hz below its calibration frequency. Supplying the reference from an external source via the BNC connector corrected the error.

When the oven-stabilized crystal oscillator (OCXO) was removed from the radio and tested independently, two facts emerged: The startup current and idle current were identical, indicating that the internal oven was not operating. Also, warming the oscillator with a lamp caused it to drift upward in frequency regardless of how much time it had been given to stabilize.

Photo 1. The oscillator frequency was measured using a frequency counter. The master clock in an HP 8647A signal generator was used as a reference.

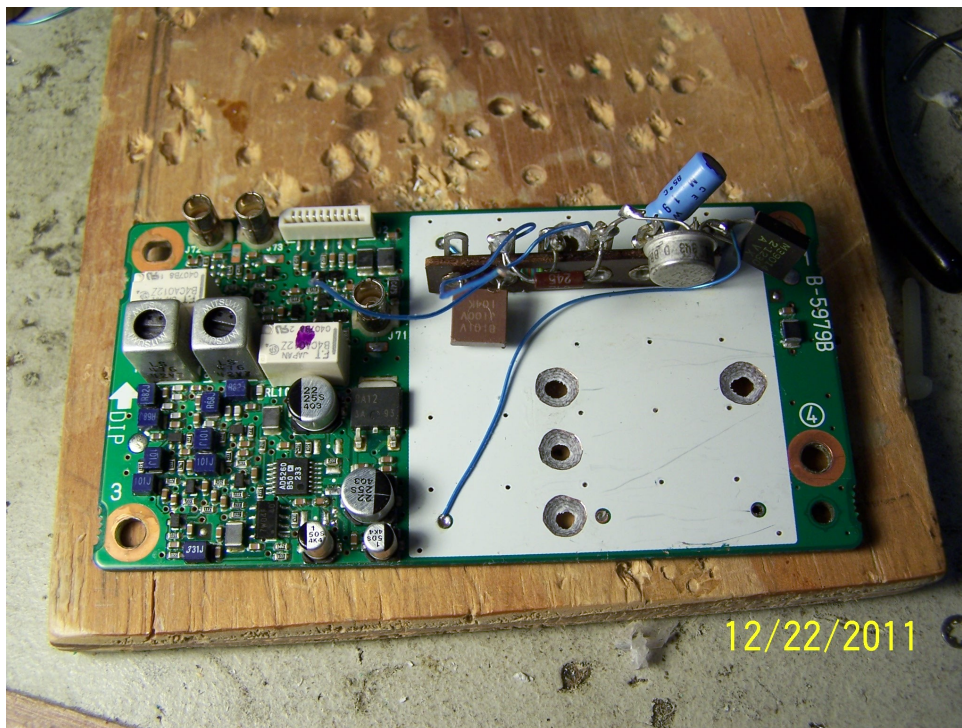
The Icom technical support staff recommended against drilling holes in the PWB, because this was likely a multi-layer board. I chose to drill the holes and then counter-sink them to half the board thickness on the top and bottom sides. When I examined each of them under a microscope, I found that this is a two-layer board and that precautions were unnecessary. See Photos 2 and 3.

Photo 2. Holes were drilled to accommodate the new oscillator pins. A countersink drill was then used to separate copper layers. Close examination showed that this is not a multi-layer PWB. (See Photo 3.)

Four 1/16 inch diameter holes were drilled in the oscillator PWB to accommodate the pins of the new part. Drilling a fifth hole was not necessary, because one pin was placed in a hole used by the original oscillator. The new part was fixed in place using several daubs of RTV sealant. The voltage reference circuit was assembled using point-to-point wiring on a small terminal strip next to the oscillator.

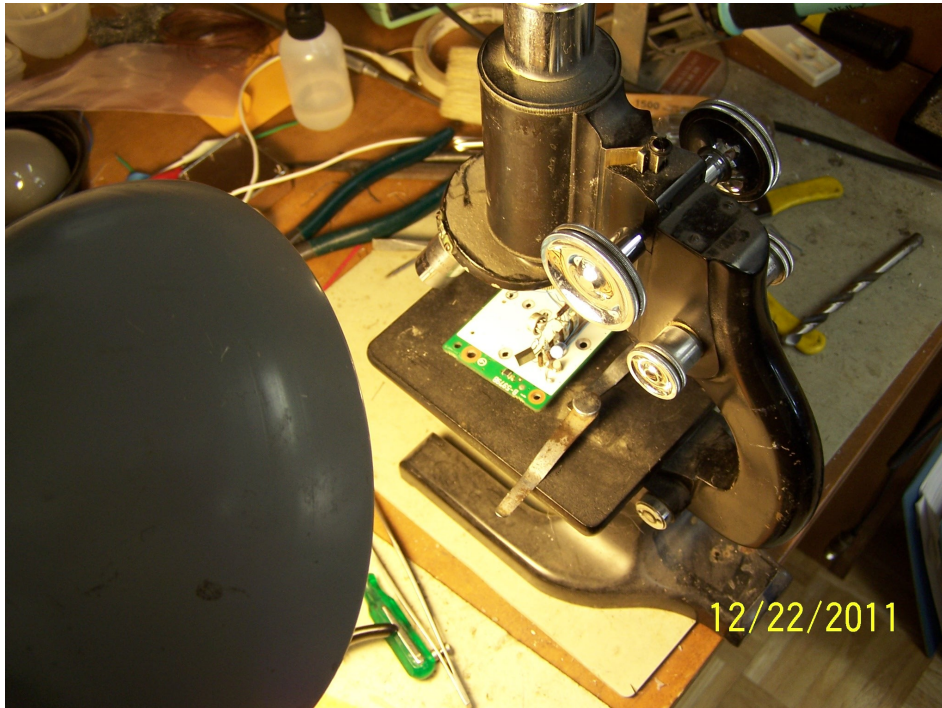
Photo 3. Checking the PWB structure using a microscope. If this had been a multi-layer board, it would have been necessary to make sure each exposed layer of copper was cleanly cut and to passivate the exposed layers with lacquer or epoxy.

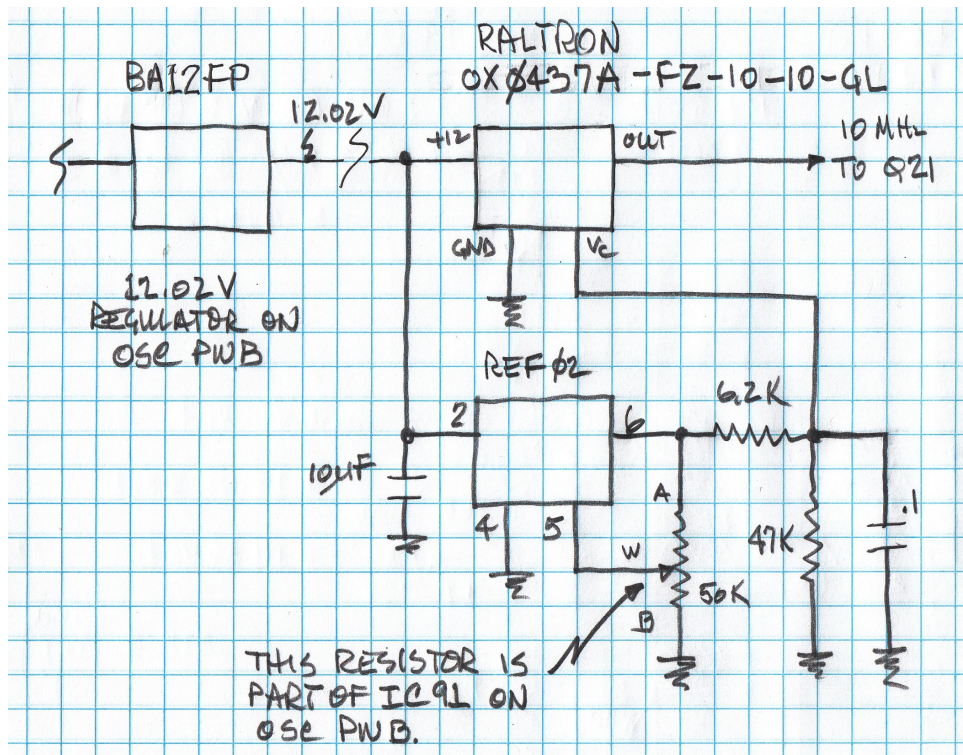
Figure 1. Regulator schematic. Fixed resistors are high-quality, 1% parts.

In the original circuit, the reference voltage developed in the OCXO is varied by a digitally-controlled potentiometer—IC91 in the schematic—before it is applied to the control (V_c) pin. Since an external voltage reference would be used in this case, the top and wiper terminals of the potentiometer (connections “A” and “W” on the schematic) were connected to the new regulator.

The station “junkbox” contained several Analog Devices REF-02 precision regulators, and one of these was used to develop the control voltage for the oscillator. The REF-02 is powered by the oscillator's dedicated 12 Volt supply, and the temperature stability of its 5 Volt output is claimed to be 8.5ppm/°C. This would not ordinarily allow the Raltron oscillator to meet its stability specification. In this case, stability is adequate because the regulator is mounted inside the enclosure, next to the OCXO. As a result, when the operating temperature has stabilized, the regulator voltage does so as well. The mounting arrangement is shown in Photo 4.

The 0.3% maximum tolerance of the regulator output voltage is unimportant, because the voltage applied to the control pin of the oscillator is adjusted by the digital pot. Since the oscillator frequency is correct when roughly 3.5 Volts is applied to the control pin, the 5 Volt output was “scaled” using a resistive divider. The divider values were chosen to produce 10.000 MHz output when the on-screen calibration graphic is close to 50 on its 0 to 100 scale. The circuit is shown in Figure 1. Photos 4 and 5 show the modified PWB and enclosure.

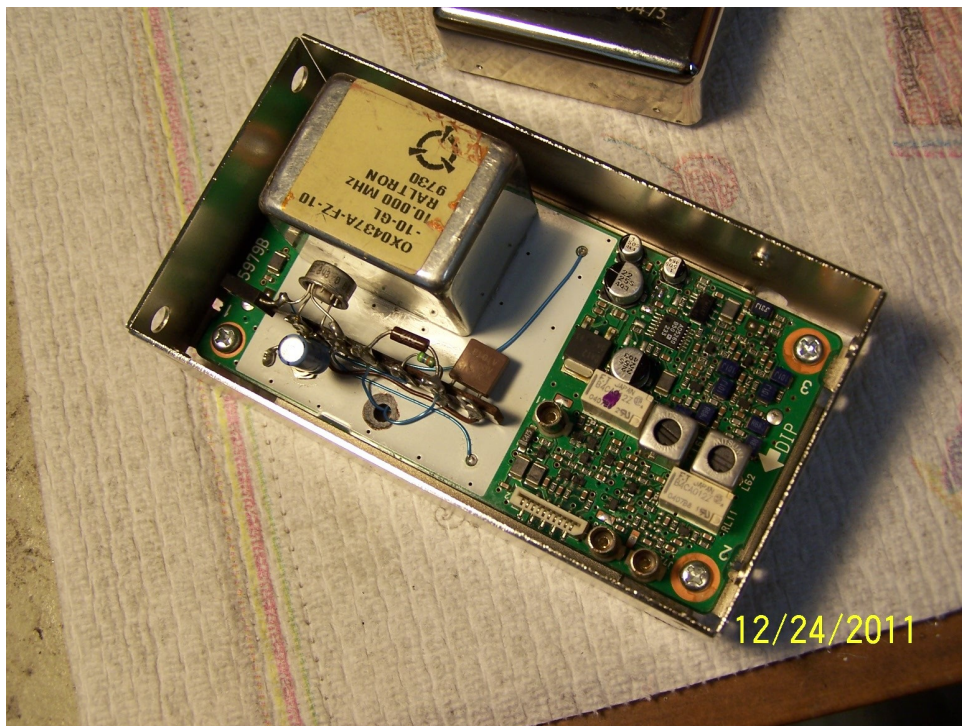
Photo 4. The modified oscillator PWB installed in the module enclosure.

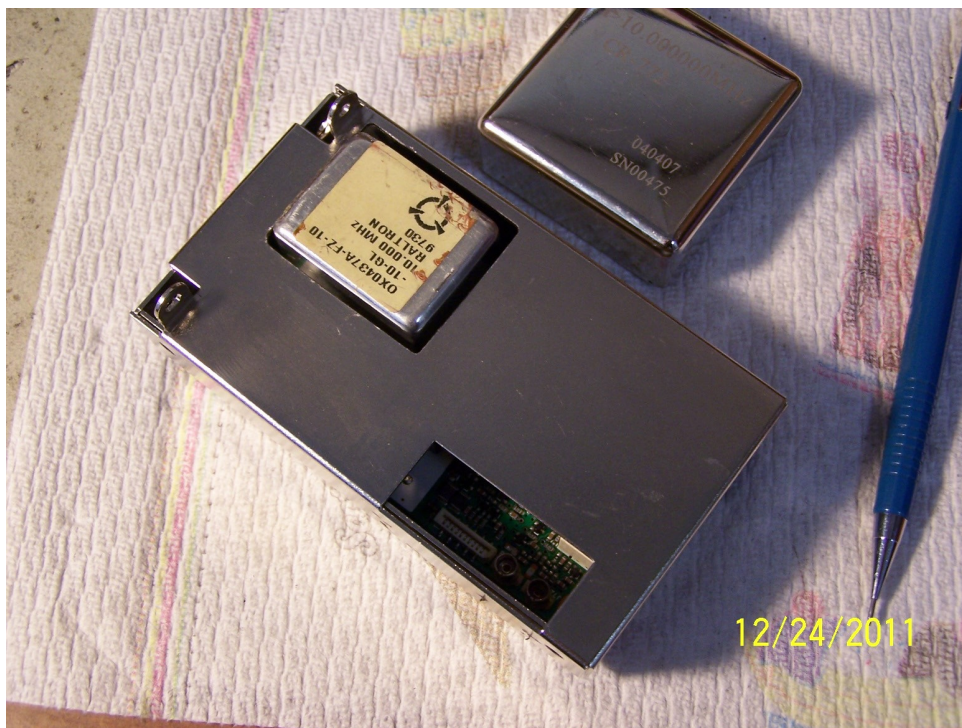
Photo 5. The oscillator module with modified cover installed. The original oscillator is visible next to the module. Coax and ribbon cable connections are made through the smaller opening in the cover.

It was necessary to make a rectangular hole in the module cover because the Raltron oscillator is taller than the original. The finished hole, with oscillator installed, is shown in Photo 5. Because the space between the antenna matching unit toward the rear of the chassis and the panel on which the DC-DC supply is mounted toward the front of the chassis is limited, the module mounting holes were filed to make them slots. This allowed centering the module in the available space. (The slotted holes are not shown in the photo.)
