Notes on Rebuilding an SB-220 Linear Amplifier (Updated Jul/13)

Brad Rehm, KV5V
Salado, Texas

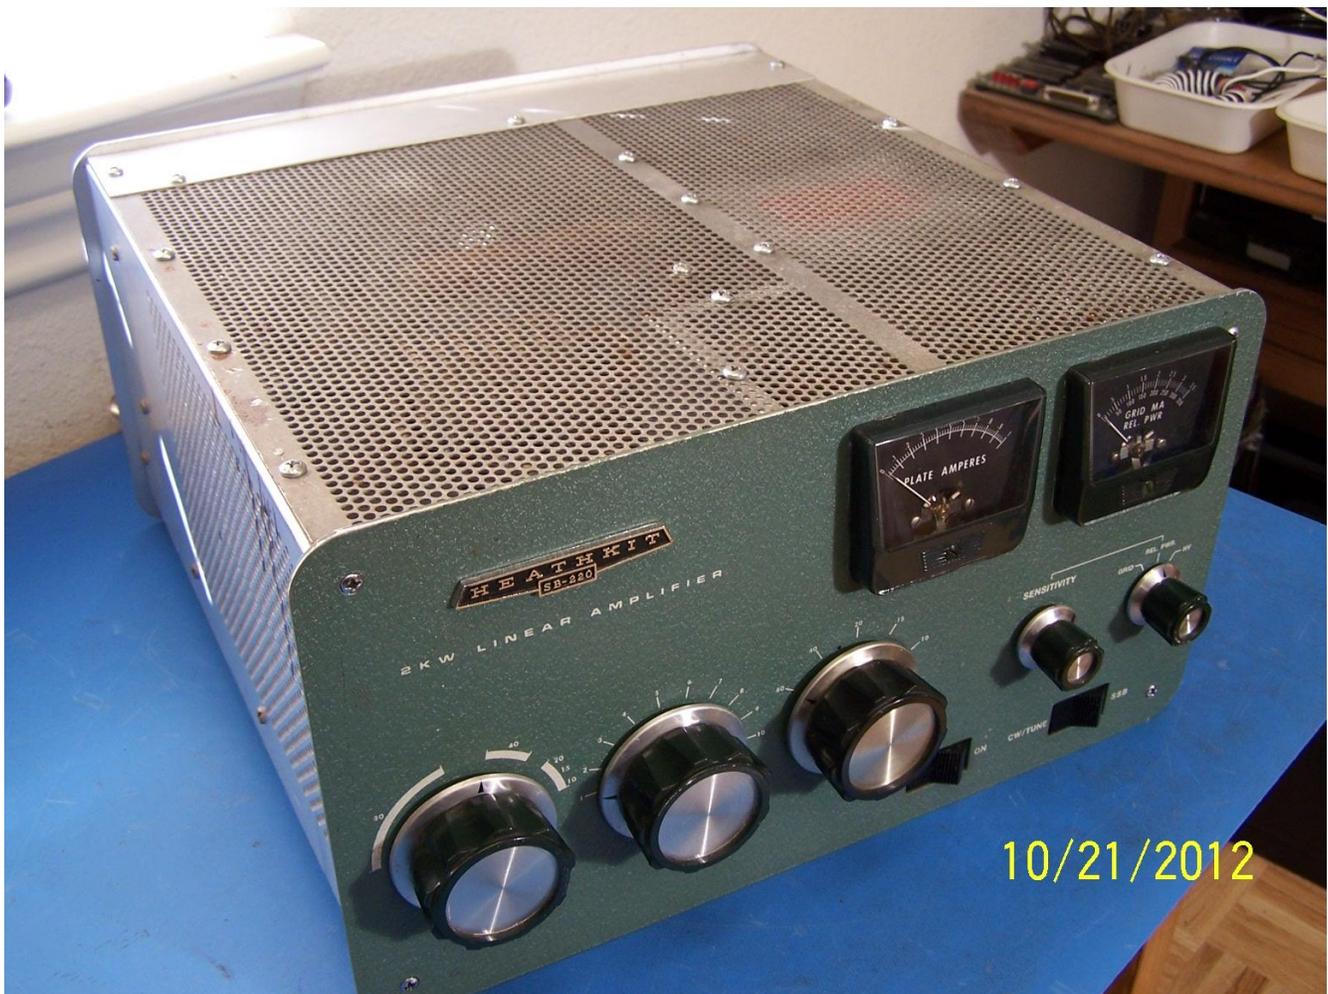
Photo 1. The Heath SB-220 at the beginning of the project. The outer enclosure has been removed.

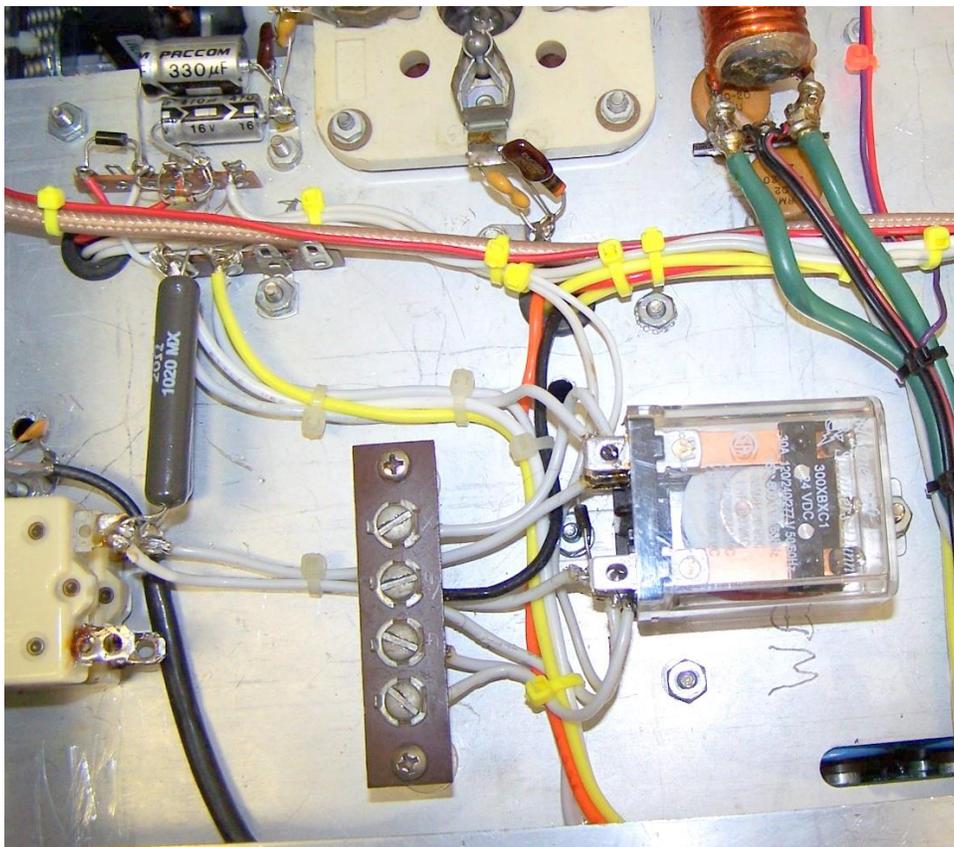
Photo 2. The components of the step-start circuit were located next to the circuit breakers and the power cord entry. The cord and voltage-select jumpers have not yet been installed.

I chose the relay approach, shown in Photo 2 above, using a simple R-C and transistor timer. The start-up current requirement of an amplifier of this size can exceed the current ratings of the largest NTC thermistors, especially when the amp is operated at 120 Volts. The relay approach can be very reliable if the resistors and relay are selected carefully. After a two-second delay, two 15 Ohm, 5 Watt resistors in parallel in each leg of the incoming AC are removed, using a double-pole, 20 Amp relay. The component values allow the simple, 28-Volt delay circuit to operate properly at 120 and 240 Volts.

Photo 2 shows the Magnecraft relay used to bypass each of the series resistors, which are located to the right and above the circuit breakers. The terminal strip to the left of the 3-500Z socket contains the 28 Volt rectifier and delay circuit. The transformer which powers this circuit was bolted to the side panel on the top of the chassis. It is shown in Photos 3 and 12. The final schematic includes the relay control circuit and 28 Volt power supply.

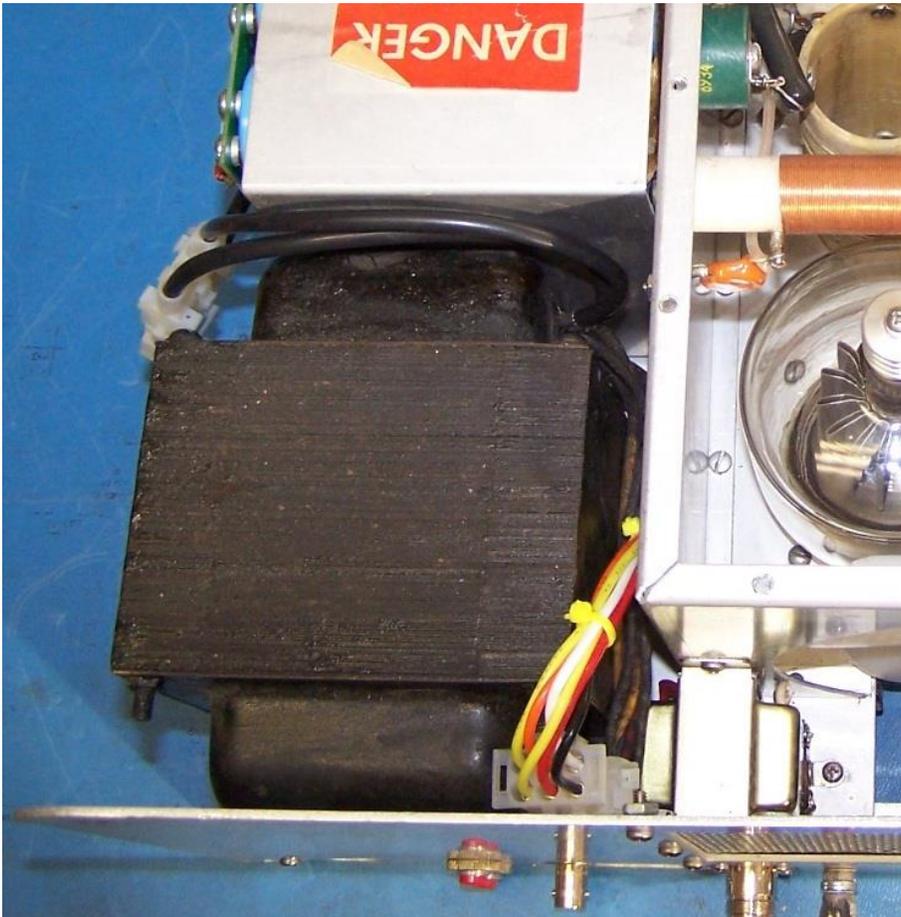
Photo 3. Molex connectors as installed at the high voltage power transformer. The connectors make it easier to remove the transformer for shipping. The original transformer was replaced with a Harbach/Peter W. Dahl unit, which increased the available high voltage from about 3200 to nearly 3500 Volts. This photo also shows the Alpha Wire sleeving which was installed on the transformer secondary leads. The breakdown rating of the sleeving is 8000 Volts.

1. Molex connectors were installed in the high voltage transformer leads and in the wiring to the front panel. These are shown in Photos 3 and 4. The primary connectors were Molex 50-84-1060 and 50-84-2060. The secondary connectors were Molex 50-84-1040 and 50-84-2040.

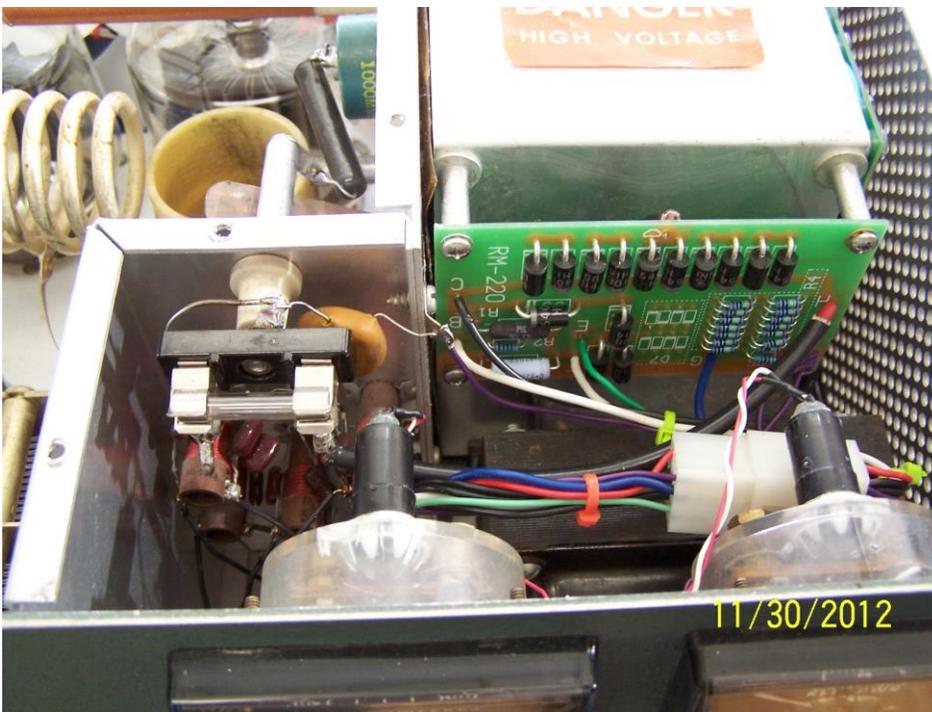
Photo 4. The Harbach diode board, which replaces the original voltage doubler board. The area of this board which contained the zener diode replacement is not populated because this function is performed by the W7RY QSK Board. Also visible in this photo is the Molex connector which allows detaching and removing the front panel. The fuse, visible

on the left side of the photo, protects the power supply and meters from tube flashovers. Not visible here is the diode recommended by W8JI to provide additional flashover protection for the meters. It has been soldered to the back of the diode board between terminal C and ground.

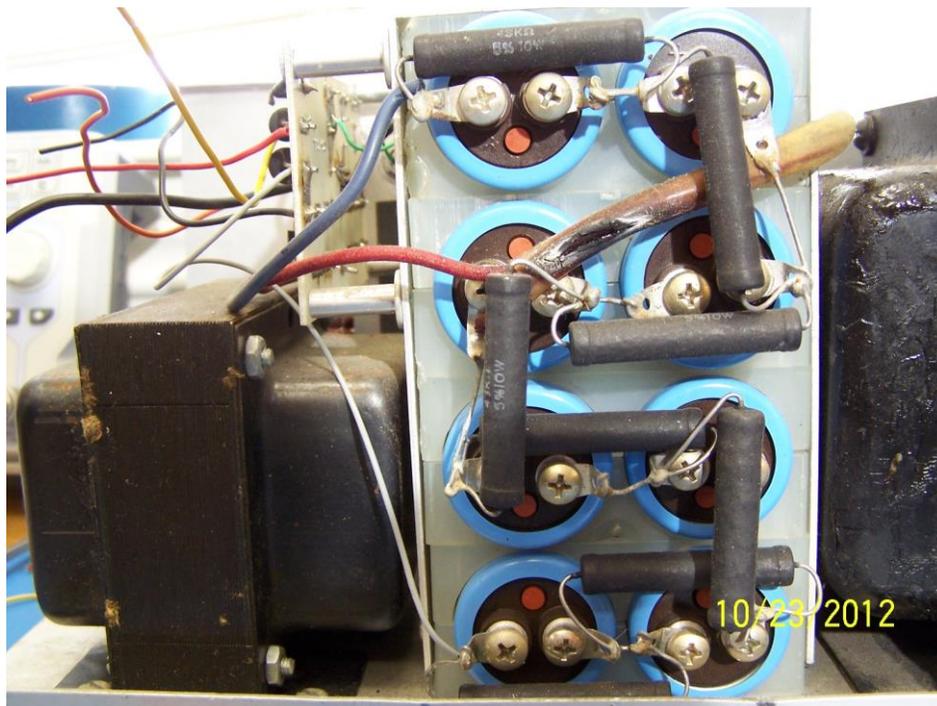
Photo 5. The original capacitor and diode board wiring. Notice the arc damage to the original transformer secondary wire and sleeving.

3. Harbach capacitor board was installed in the power supply. In addition to improving the appearance of the capacitor bank, the capacitor board includes new bleeder resistors and adds reverse diodes to protect the amplifier during tube flashovers. The old and new capacitor wiring are shown in Photos 5 and 6. Notice the damage to the original transformer secondary lead from arcing through the insulating sleeving in Photo 5.

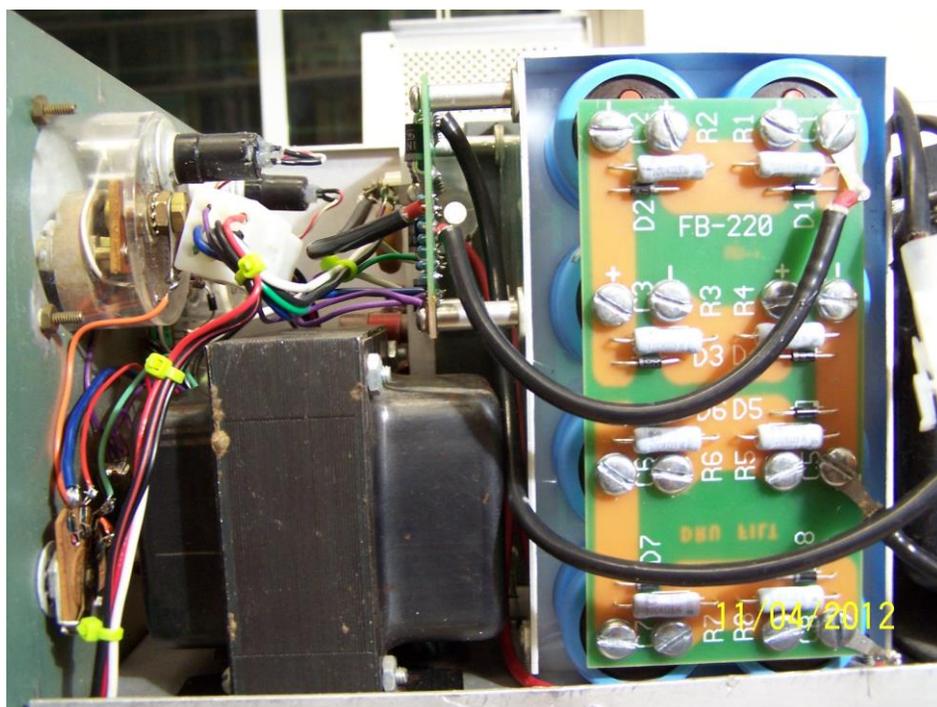
Photo 6. The Harbach capacitor and diode boards replaced the original wiring and PWB. Alpha Wire sleeving was used on all the high voltage wiring. The new front panel wiring and

white meter LEDs are also visible in this photo.

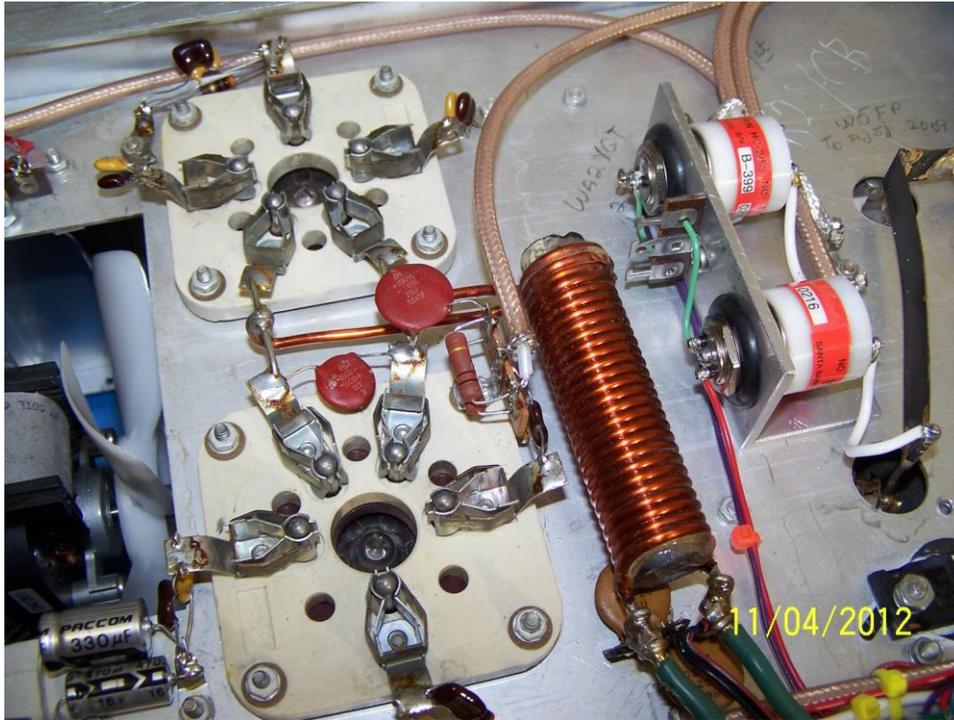
Photo 7. Kilovac HC-2 vacuum relays are shown in this photo. The resistor which sets current through the relays at 60 mA will be installed on the terminal strip between the relays.

The relays are mounted in rubber grommets (Mouser 534-750) to reduce mechanical switching noise. Also visible in this photo are the parallel 10 Ohm resistors in series with the coax and RF drive to the filaments. These reduce the Q of the bandswitch-to-tube wiring.

- of the board to reduce the chance of damage from tube flashovers. (See the discussion of this change below.)
- 5. The ALC circuitry was removed because reliable ALC loops are already incorporated in modern transceivers.
- 6. The three-pole antenna- and bias-switching relay was discarded, and several components were added to replace it. The vacuum relays are shown in Photo 7. The upgrades accomplished with the W7RY QSK Board are discussed below. All coax in the SB-220

The first step in preventing this kind of damage is to abandon the practice of isolating the grids of the tubes from ground with chokes, resistors, or fuses. Photo 7 shows resistors installed between one of the grid terminals on each tube and each grid pin taken to RF ground with pairs of capacitors. These were replaced with buss wire connections to ground. The ground connection ensures that the grids can never be driven very positive in a flashover

The other circuit controls the antenna changeover relays. Jim recommends using a reed relay at the amp input and a vacuum relay at the output. His schematic includes resistors which equalize the currents in the two series-connected relays. Having had unhappy experiences with reed relays in other applications, Russ and I chose to use two Kilovac HC-2 vacuum relays. HC-1s might have been a better choice, but HC-2s were on-hand, and they have worked well in the project as well as several others. Since plenty of voltage is available to operate the series-connected relays, they switch very rapidly. A series resistor limits current to about 60 mA. Adding a capacitor across the resistor could have been used to further reduce switching time, but this was not deemed necessary.

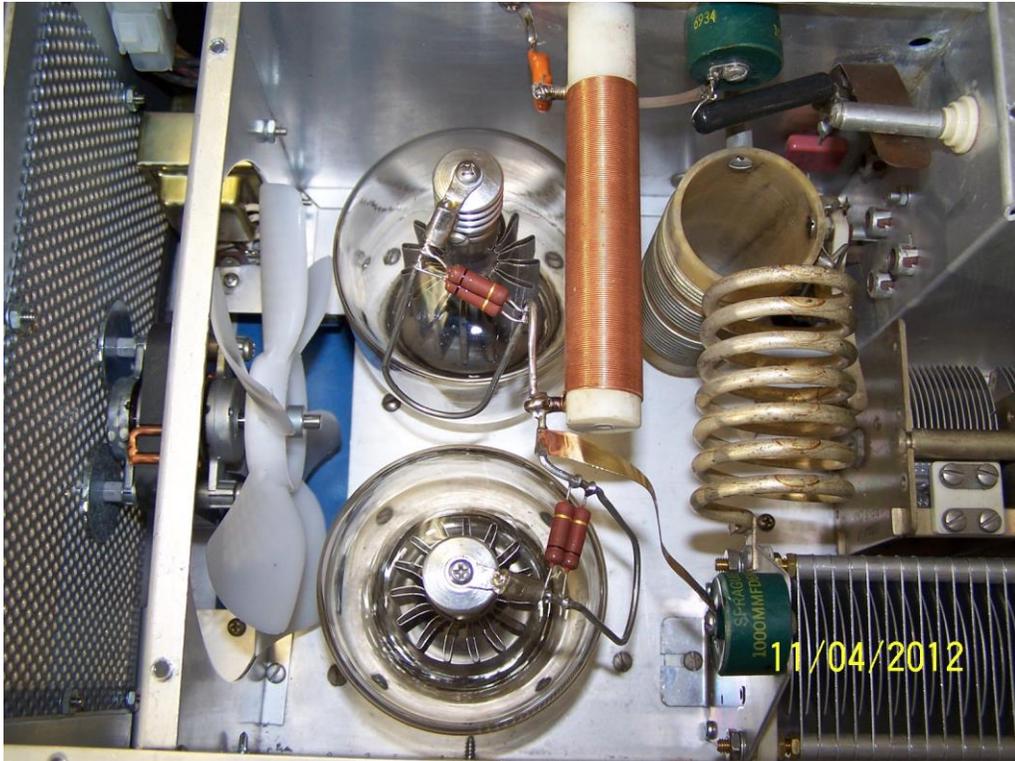
Photo 8. The hairpin parasitic chokes are supported by the plate choke. The Q-killer resistors are placed at the “bottom” of each choke. Notice the ceramic disc capacitor which was added at the base of the plate choke. The new fan and motor are visible to the left of the tubes. The mounting bolts were replaced with longer ones, which permitted using fender washers on the inside and outside surfaces of the intake grill. These reduced motor vibration. The small transformer above the fan motor was later moved to the opposite side of the fan because the space was needed for the larger Peter W. Dahl transformer.

Hairpin loops shunted by low-inductance resistors have self-resonant frequencies well above the VHF range and appear to work well as parasitic suppressors. The loops are typically just wide enough to allow the resistors to be soldered across the bases, and they are made somewhat longer than they are wide. I haven't seen the loop dimensions fully-defined yet, but Richard Measures, AG6K, gives a fairly complete description in his on-line paper on the TL-922 and the SB-220. (See the "Anode Circuit Modification" section of <http://www.somis.org/QSK922.html>.) Although Measures also recommends using nichrome wire for the loop, I have found 12-gauge, tinned buss wire to be satisfactory. Photo 8 shows the hairpin loops installed in this SB-220. Observing the output of the amp with a spectrum analyzer, I have found no tendency to oscillate, even under a variety of load conditions.

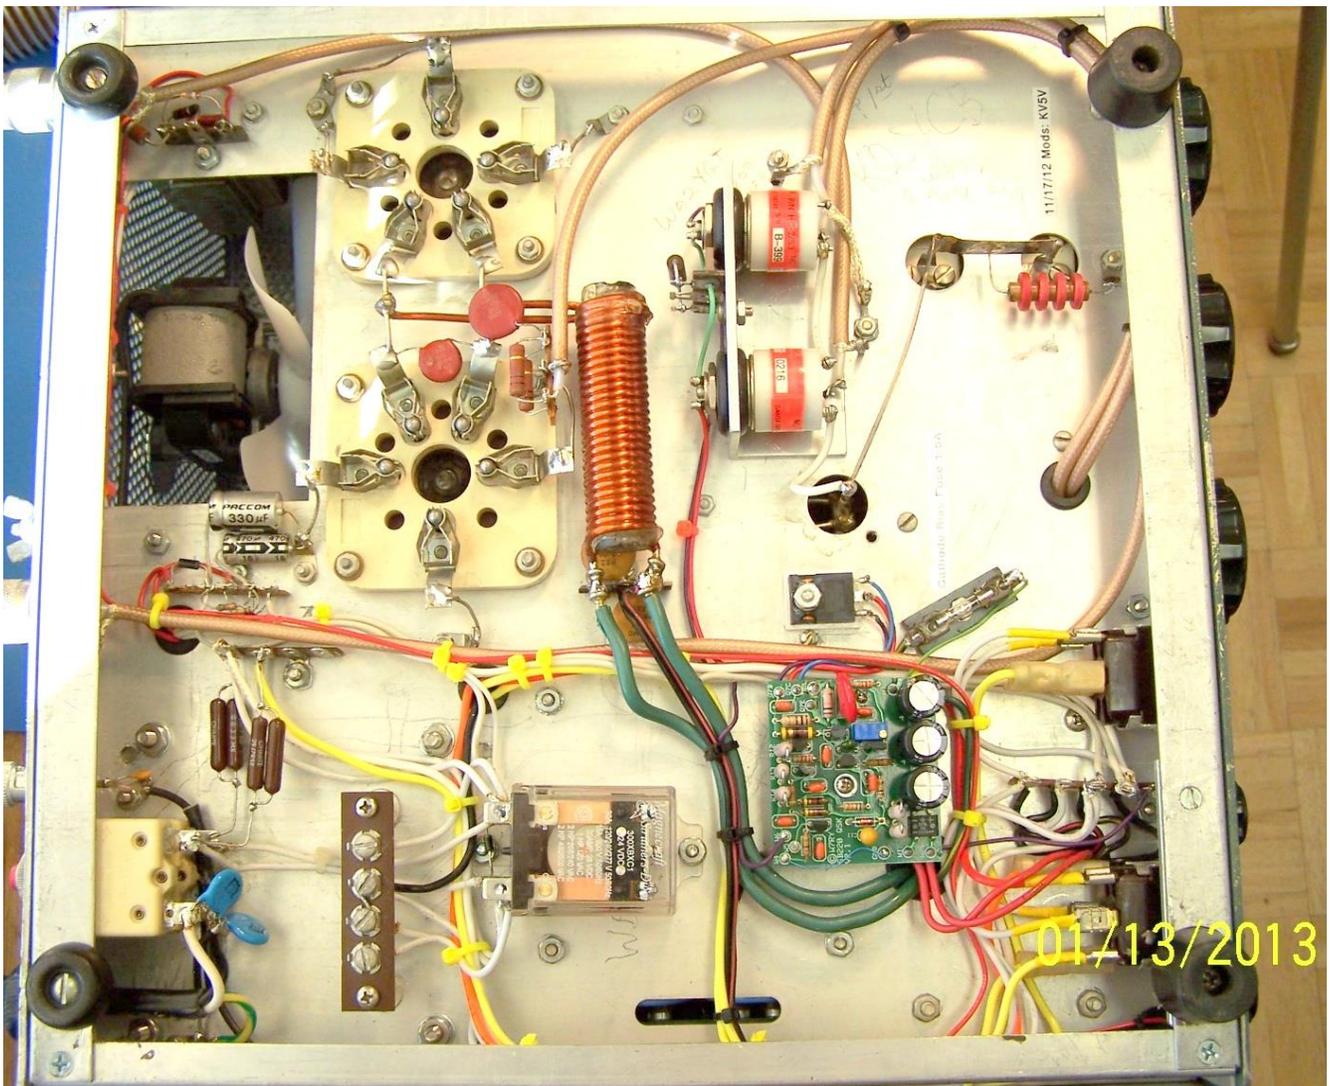
Photo 9. The finished underside of the amp. The QSK Board is on the lower-right in this photo. The Darlington bias-control transistor and filament center-tap fuse are mounted just above it, using available chassis holes.

The QSK Board has a role in preventing catastrophic failures in the SB-220, because a failure mode of the Zener diode which controls cathode bias in the original circuit is a short circuit. When the Zener fails in this manner, the tubes are turned fully on, and damage can result when excessive current flows. The QSK Board uses a TIP147 power transistor which is protected by an MOV (a Metal-Oxide Varistor). If the transistor should fail, the voltage across the varistor would rise to its 130 Volt avalanche rating, thus biasing the tubes into cut-off. The normal failure mode for an MOV is to go open, but this only occurs after the part has been driven into conduction many times. The scheme isn't completely failure-proof, but I believe it's less failure-prone than the original circuit. The installed board is shown in Photo 9.

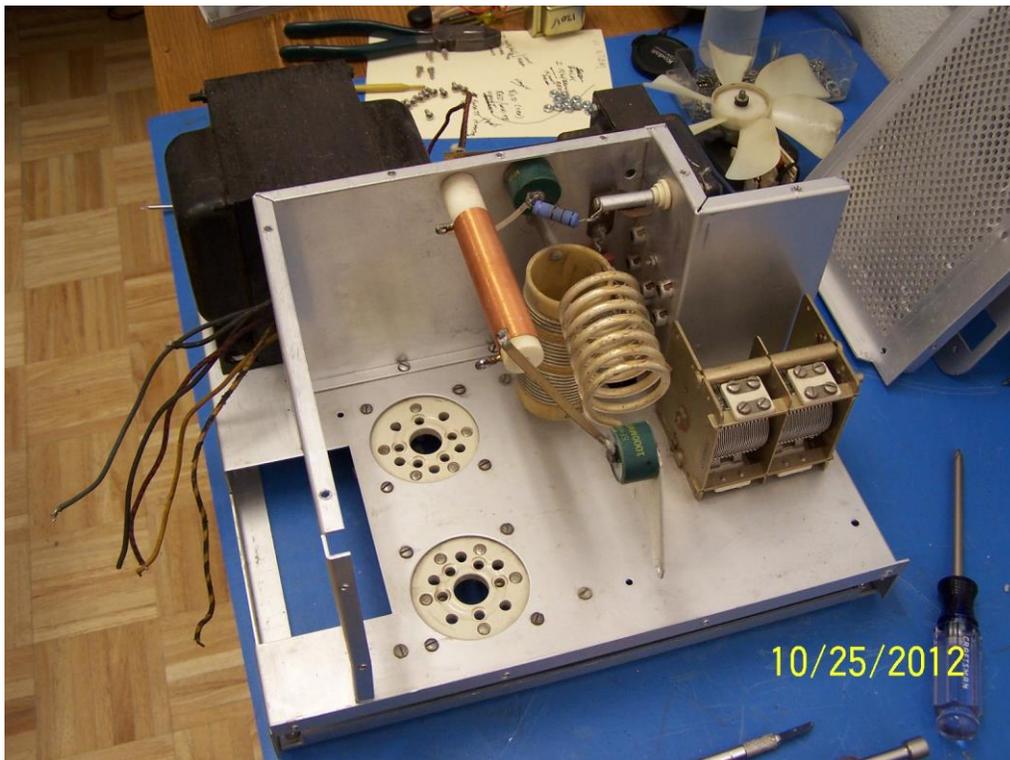
Photo 10. Most components have been removed so that the chassis can be cleaned and old hardware can be replaced. The resistor which feeds high voltage to the bypass capacitor and plate choke was also replaced.⁷

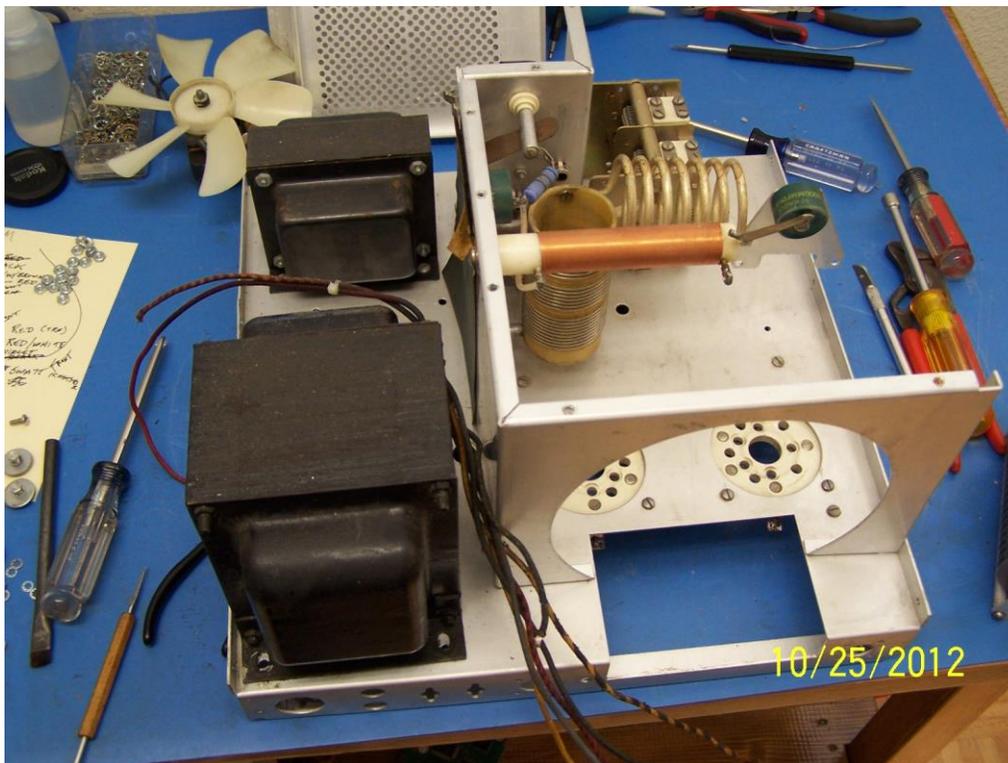
Photo 11. Another view of the chassis, ready for rewiring. One RCA connector on the rear of

the chassis was removed. The other was replaced with a BNC at the "Relay" input.

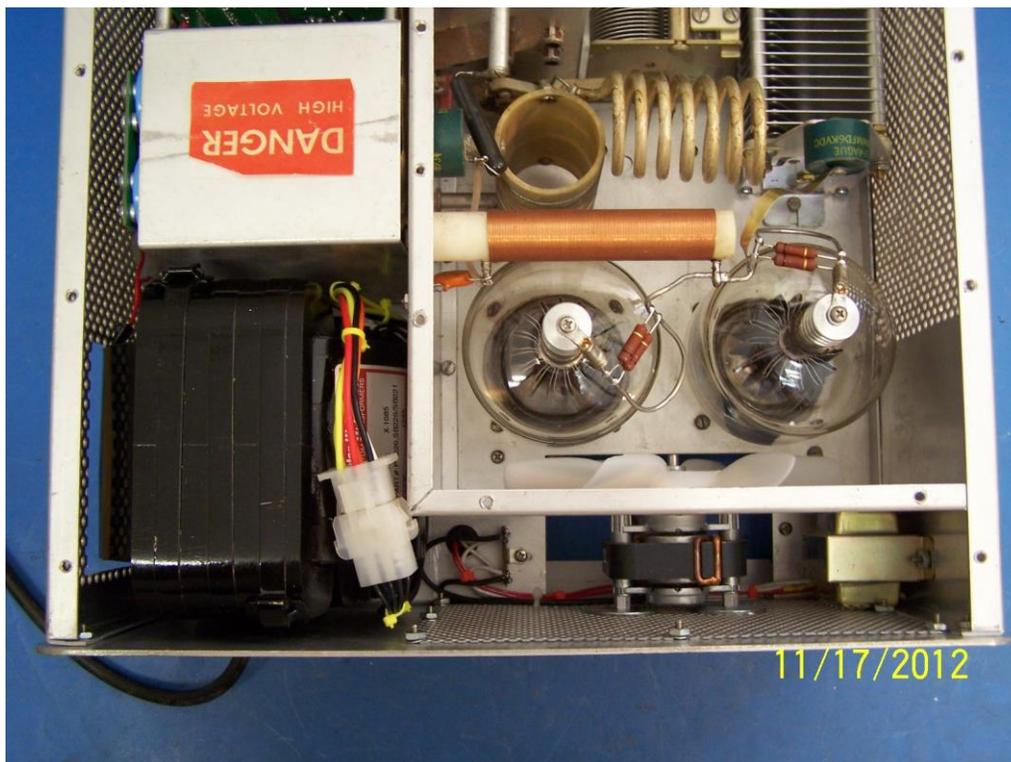
Photo 12. This view shows the Harbach/Peter Dahl HV transformer, which is slightly larger than the original transformer. The 24 Volt transformer which supplies power for the step-start circuit has been moved to the lower-right corner to make room for the Harbach.

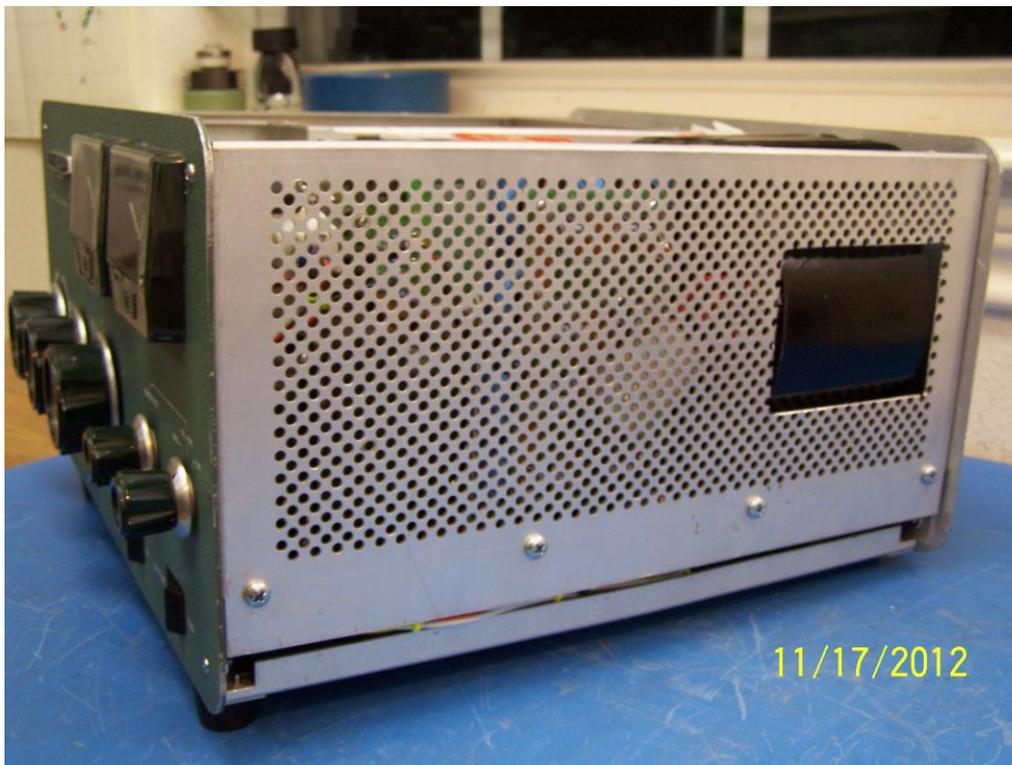
Photo 12. It was necessary to cut a rectangular hole in the right-side panel to make room for the Harbach transformer. The transformer will not interfere with the outer enclosure for the amp.
